# A Method to check the Connectivity for the ATLAS TRT Detector

N. Ghodbane <sup>a</sup>, X. Pons <sup>a</sup>, O. M. Rohne <sup>b</sup>

## Abstract

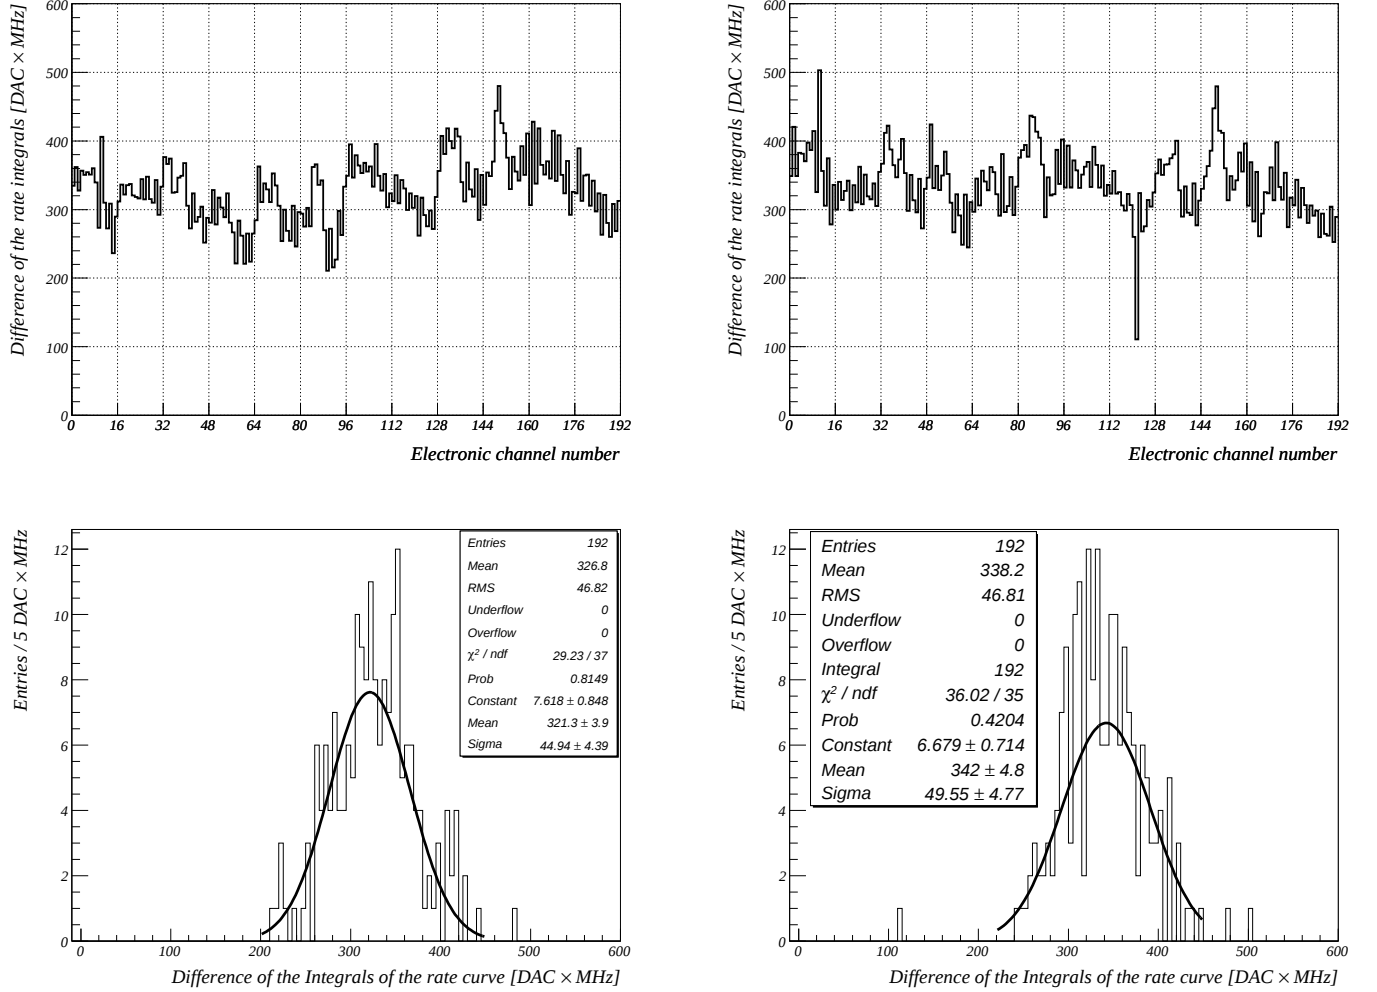
This is illustrated on Fig. 6 which shows the difference between the two noise rate integrals for a well-behaved WEB and for a WEB with one channel displaying metallisation problems not seen during the acceptance testing. For the well-behaved WEB, the distribution is centered around 320 DAC×MHz counts with a Gaussian RMS of about 50 DAC×MHz counts. Problematic channels appear at much lower values and front-end board behavior have been removed by fitting each distribution to find its mean and RMS.

Figure 6: Top: Distribution of the difference between the noise rate integral on-detector and off-detector as a function of channel number for a well-behaved WEB (left) and for a WEB with one channel displaying metallisation problems not identified by the acceptance tests (right). Bottom: distribution of the noise rate integral difference for the same WEBs as above.

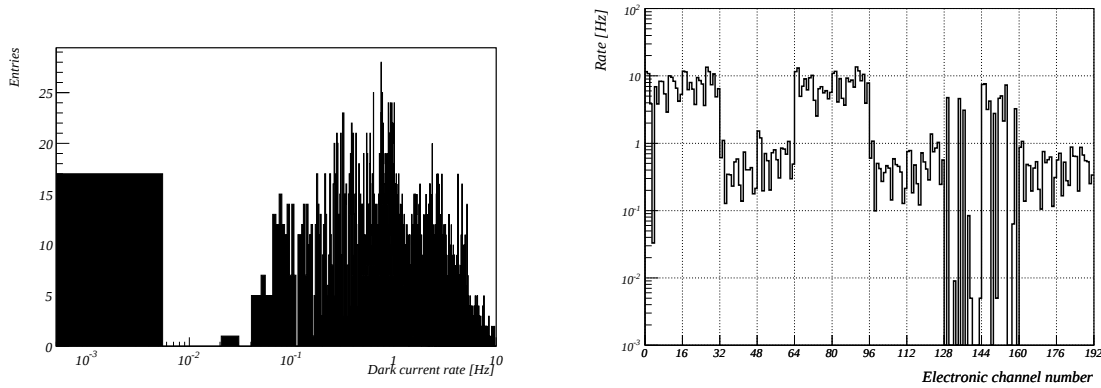
A distribution of the rate is shown on Fig. 8. Typically, working channels have a rate value greater than 0.1 Hz, whereas problematic ones have values below 0.01 Hz. For some TRT endcap-wheels, the accumulation rate distribution shows clearly a larger activity on one of the lowest of the two 4-Planes wheels, whereas for other ones a rate of about 1 Hz is measured across all the readout channels.

Figure 8: Rate distribution for one TRT endcap WEB, using the DTMROC accumulation mode. Problematic channels have a very low activity, i.e. accumulation mode rates below 10 mHz.

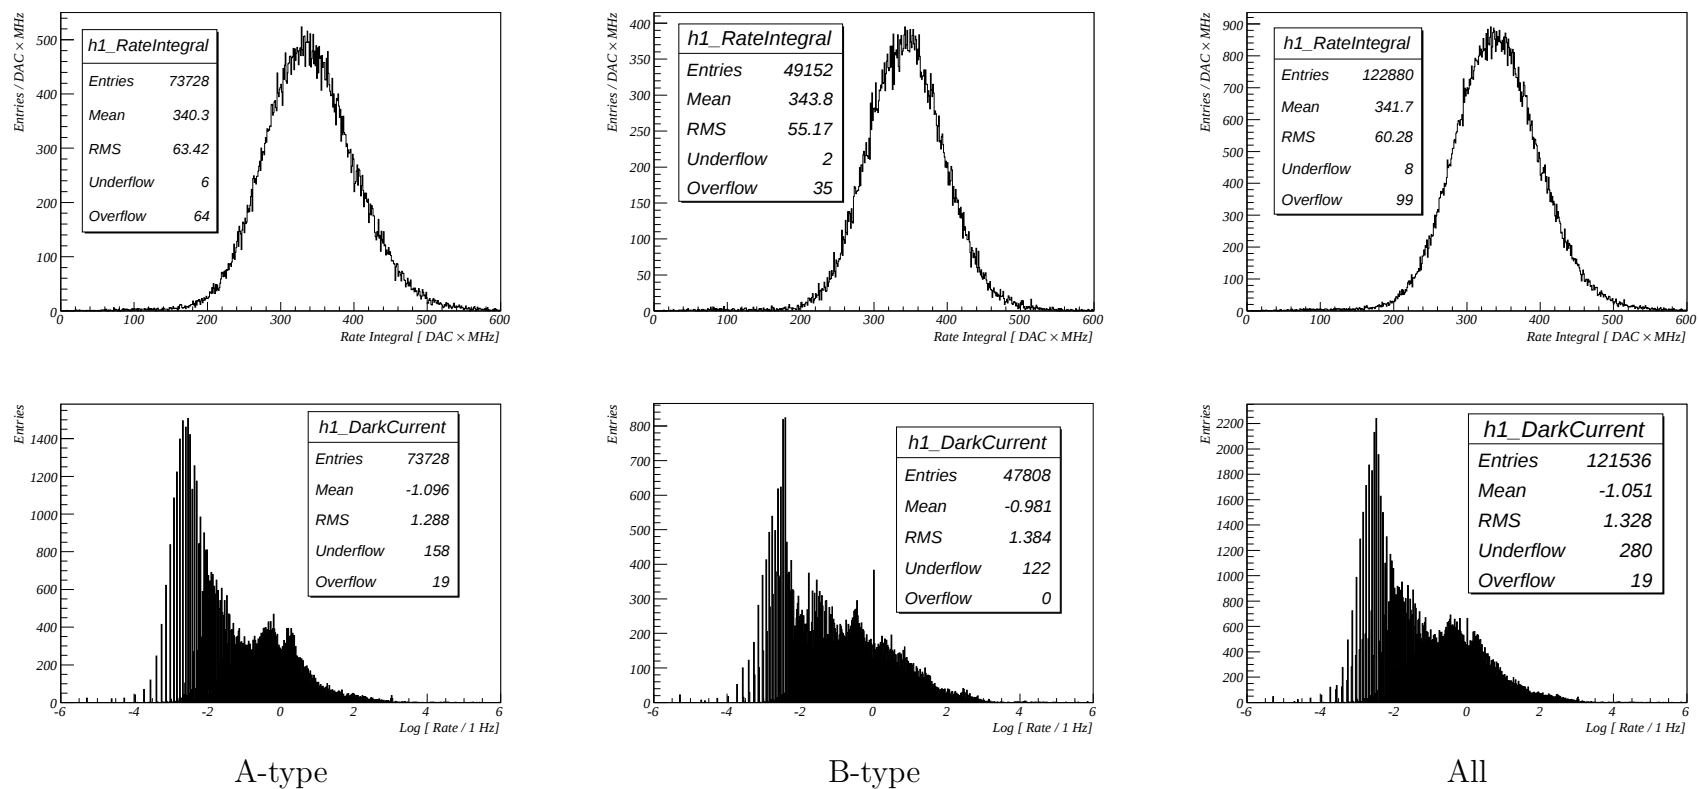
Figure 9: Noise scan rate integral distribution (upper) and associated accumulation mode dark current rate for both A-Type and B-Type TRT endcap-detectors.

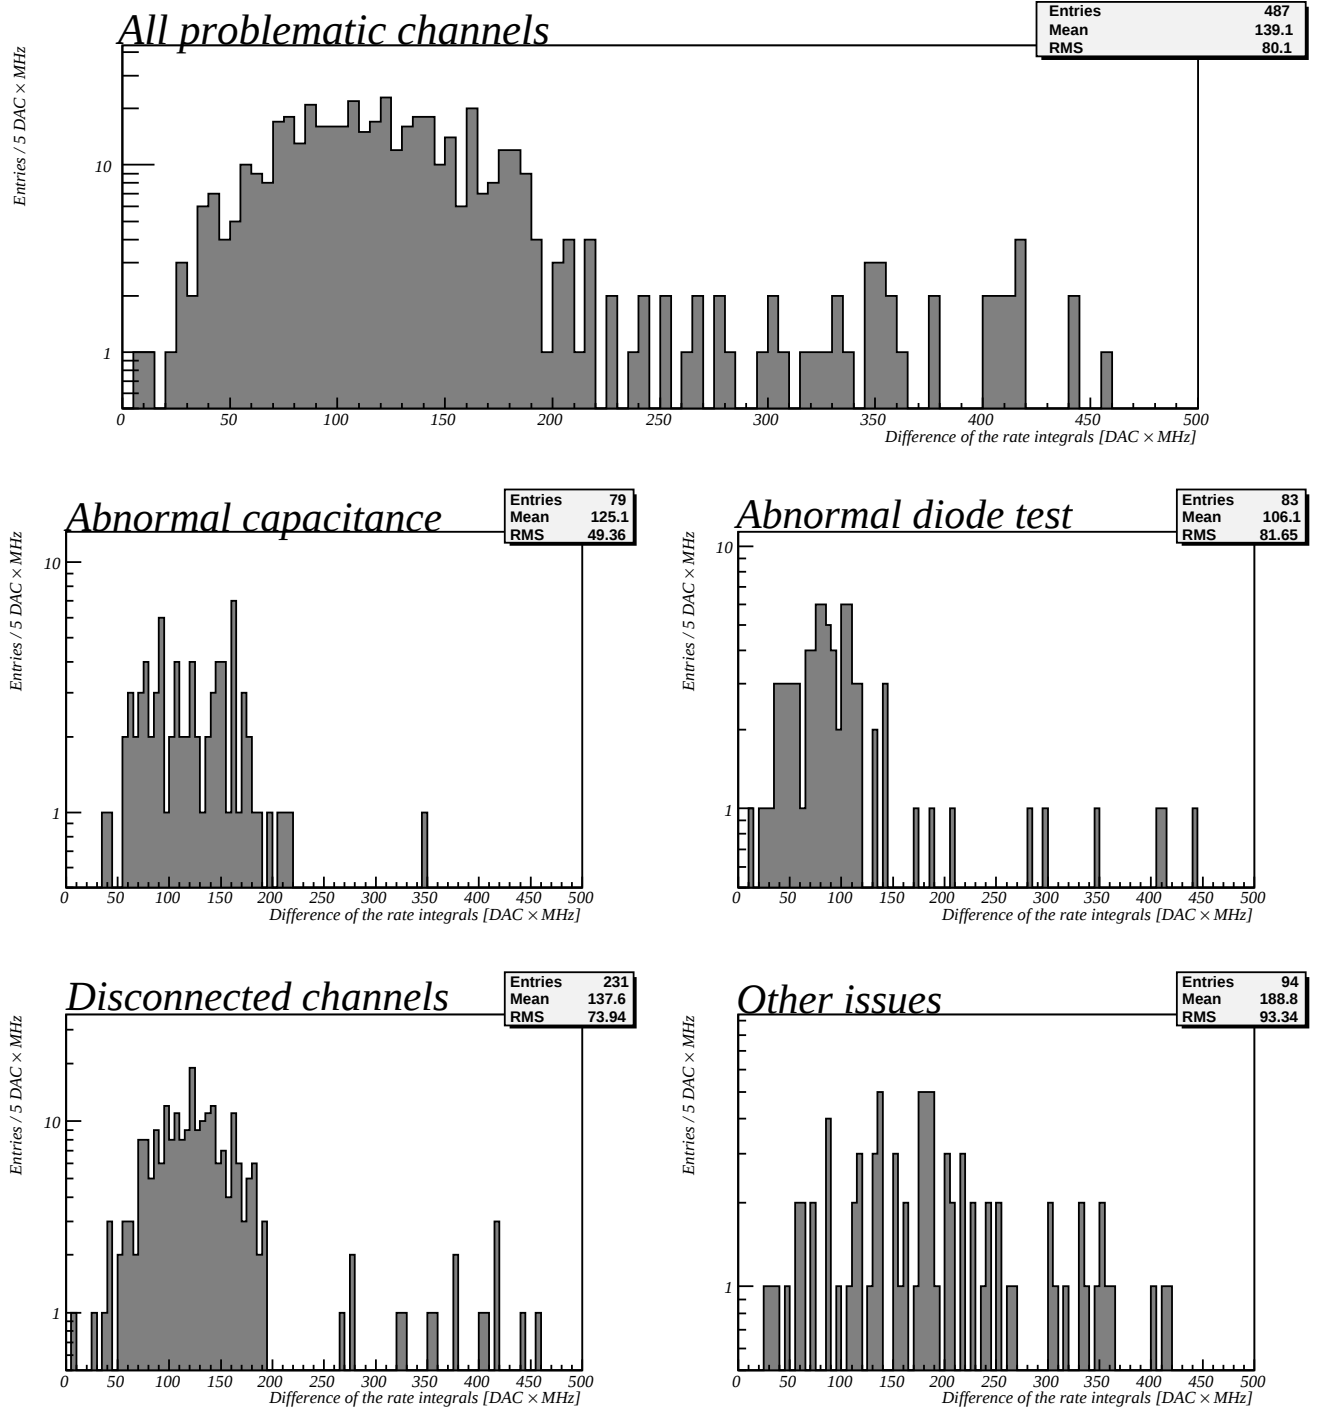
Finally, only 487 readout channels are found not to be responding. These channels comprise 231 channels for which the protection resistors were unsoldered after they failed the serie of acceptance tests. Typically, these channels are characterised by a noise scan rate integral difference value about 130 DAC×MHz counts, much lower than the WEB average ( below three  $\sigma$  of the mean value  $\mu$ ). The total distribution of the rate integral is presented on Fig. 10. In addition, their corresponding accumulation mode rate is about 10 times lower than

Figure 10: Rate integral distribution of the different problematic channels for A-type and B-type TRT wheels.

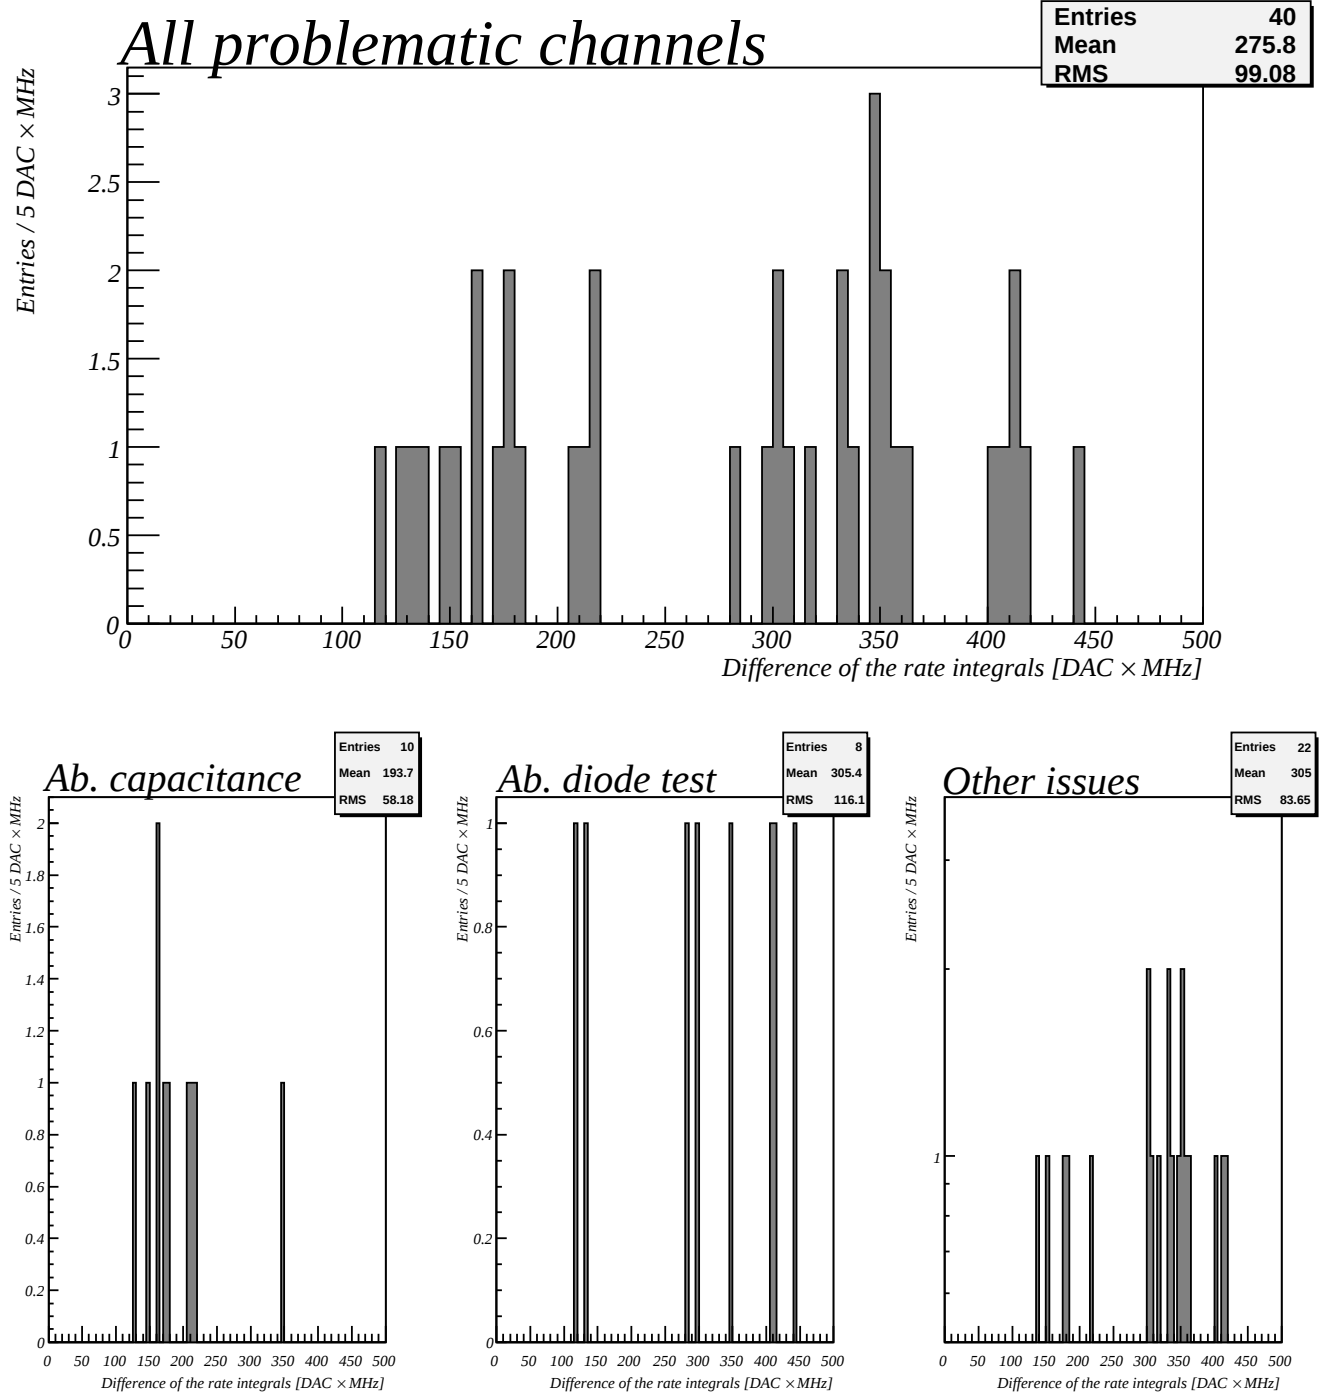
The efficiency of the two methods described in the previous section is clearly established. it enables to find 256 new problematic channels, most of them being reported non working by both methods. For instance, only 40 channels are not found by the noise scan based technique (see Fig. 10, 11, 12, 13, 14 and 15).

Figure 11: Rate integral distribution of the different problematic channels failing the Noise Scan technique for A-type and B-type TRT wheels.

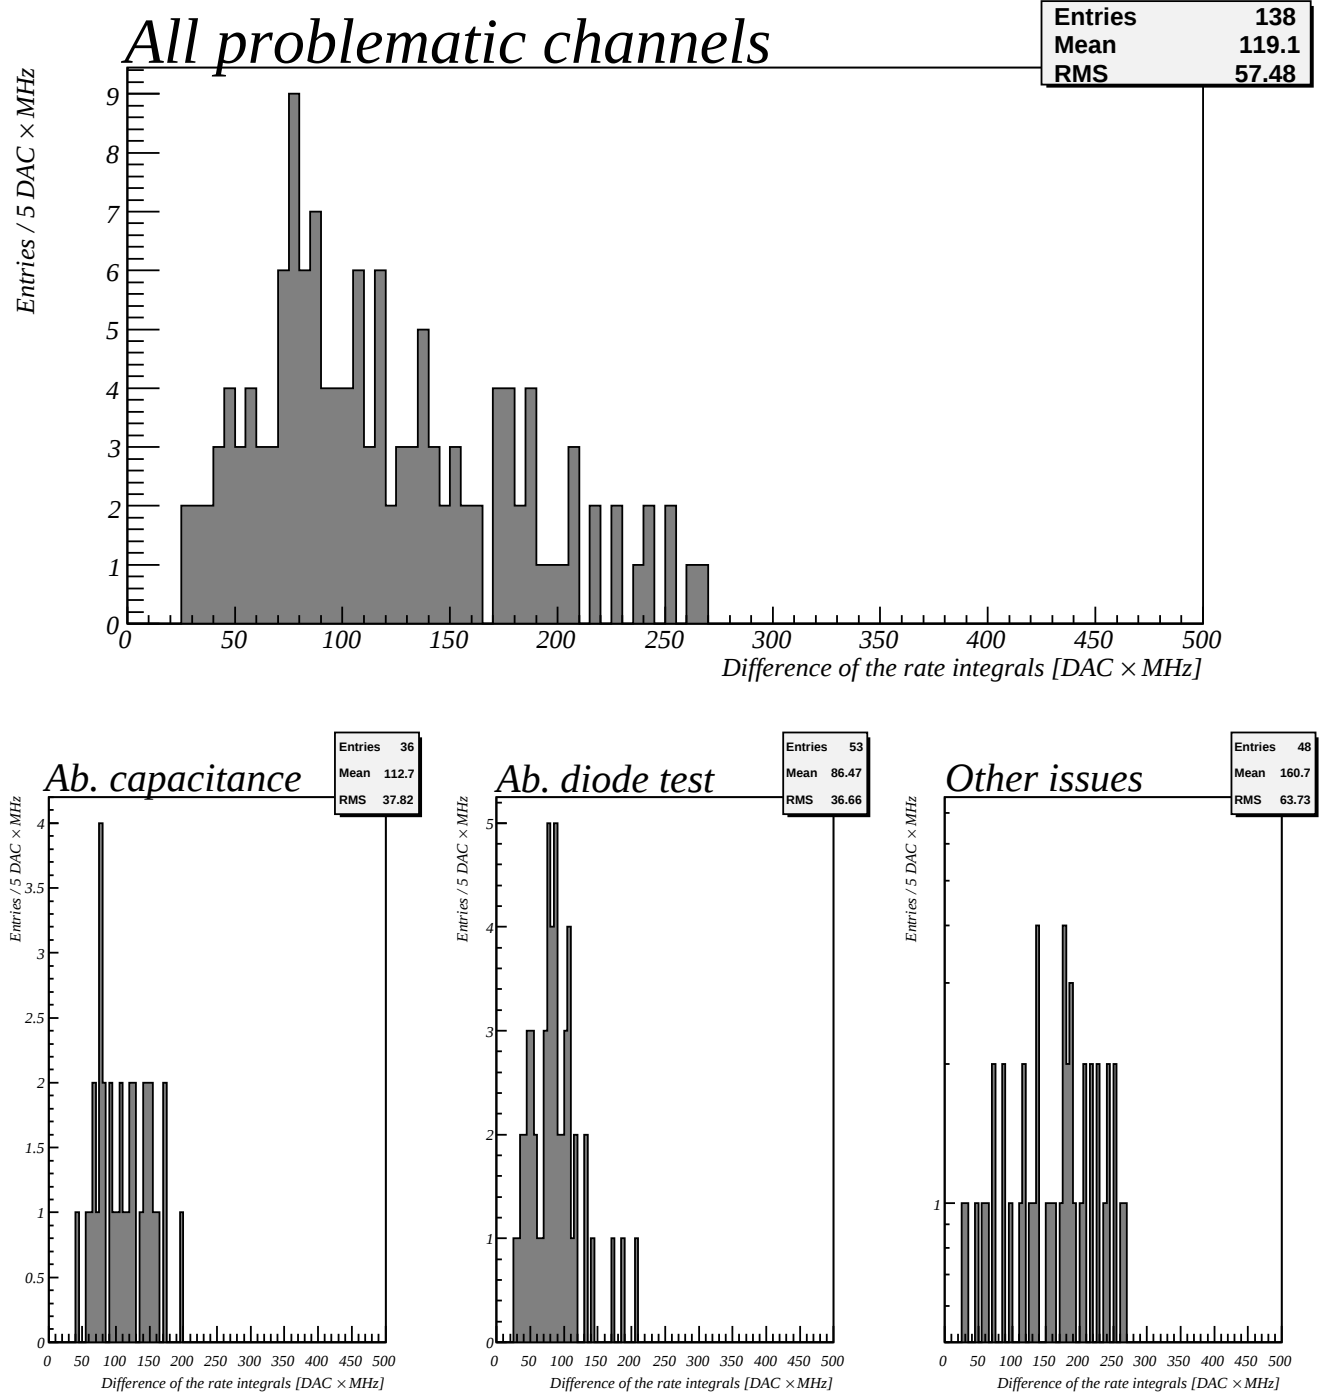
Figure 12: Rate integral distribution of the different problematic channels failing the Accumulation mode technique for A-type and B-type TRT wheels.

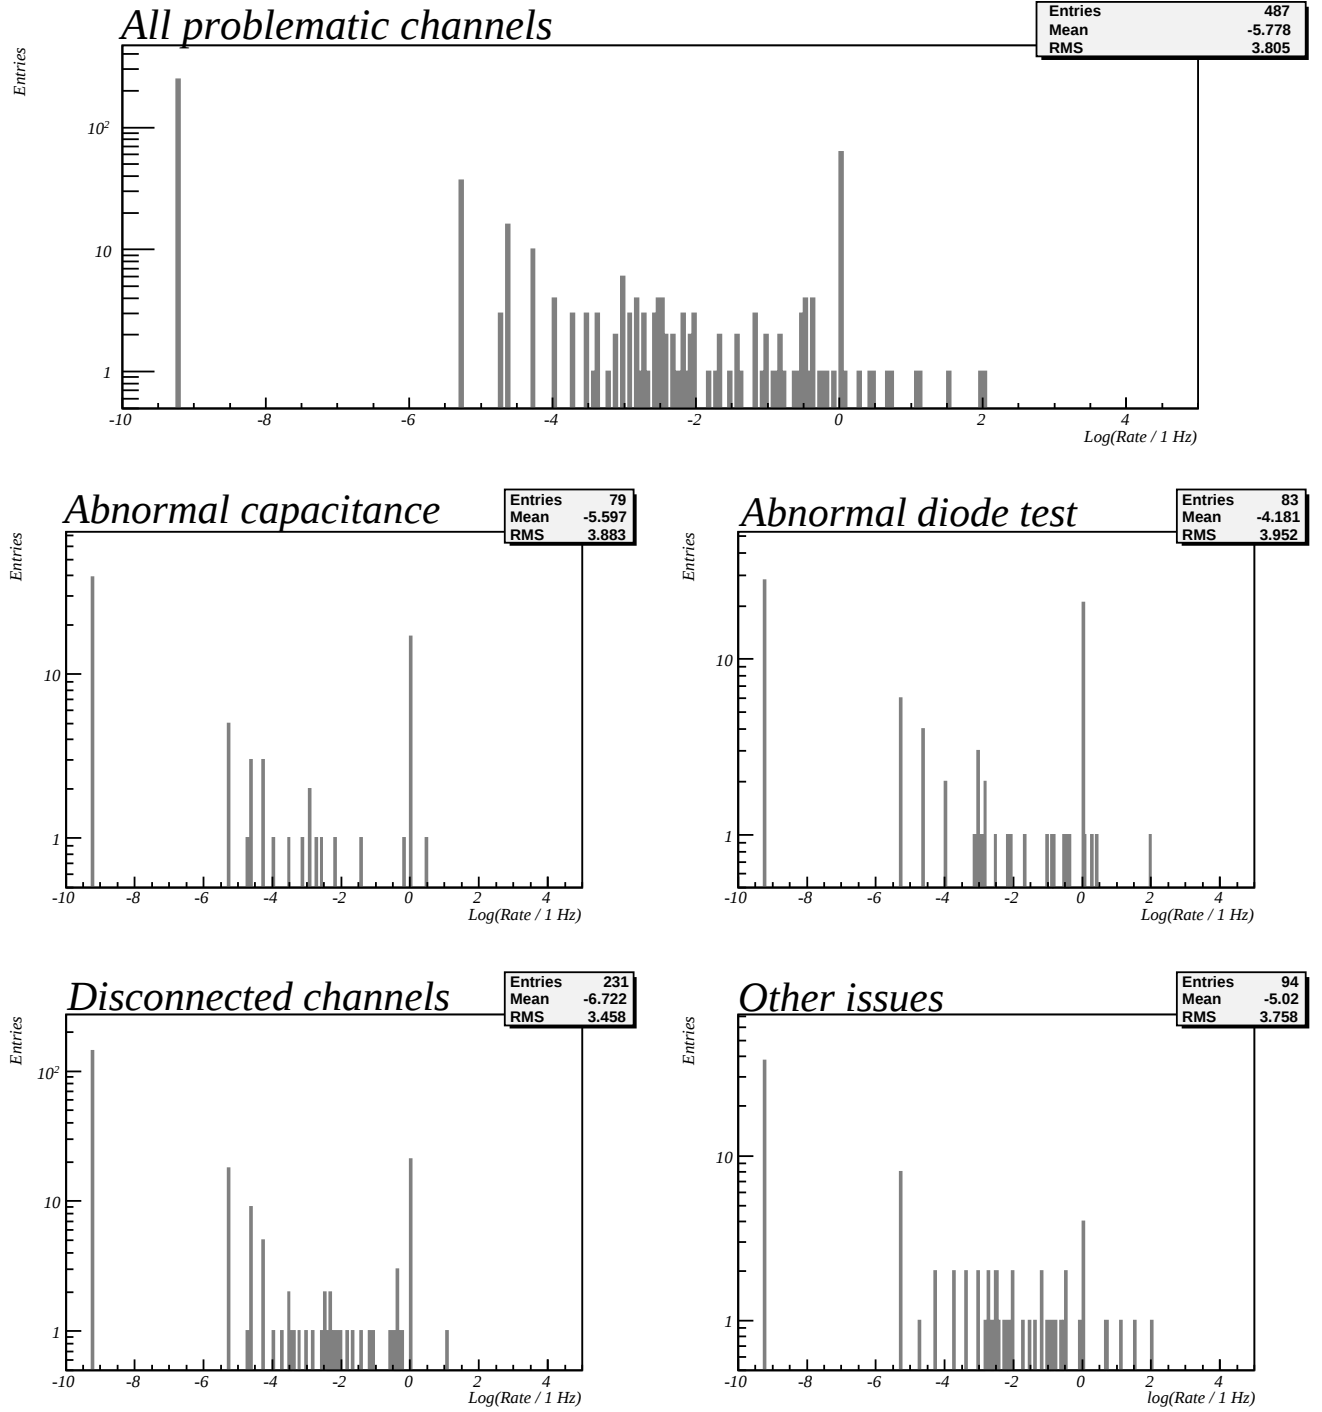
the WEB average, below 0.01 Hz and reaches for most of these channels a typical value of 0 Hz (see Fig. 13).

Figure 13: Dark current rate distribution of the different problematic channels for A-type and B-type TRT wheels.

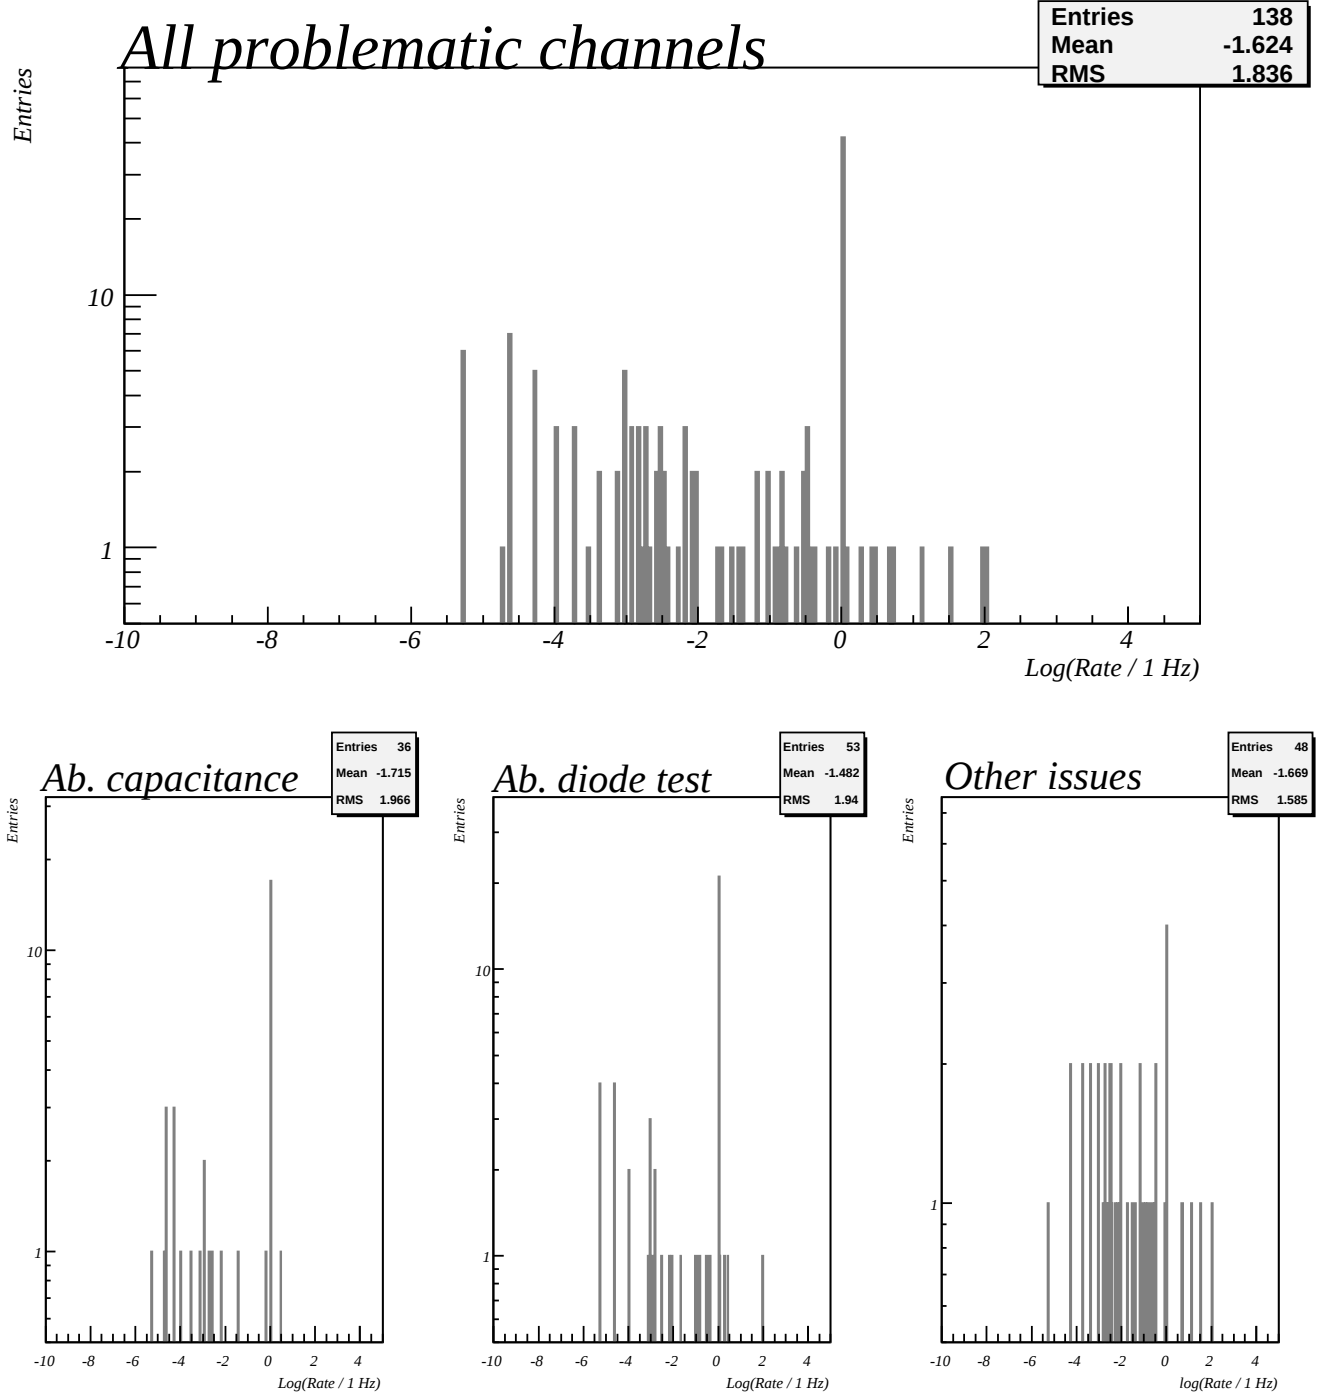
Figure 14: Dark current distribution of the different problematic channels failing the Accumulation mode technique for A-type and B-type TRT wheels.

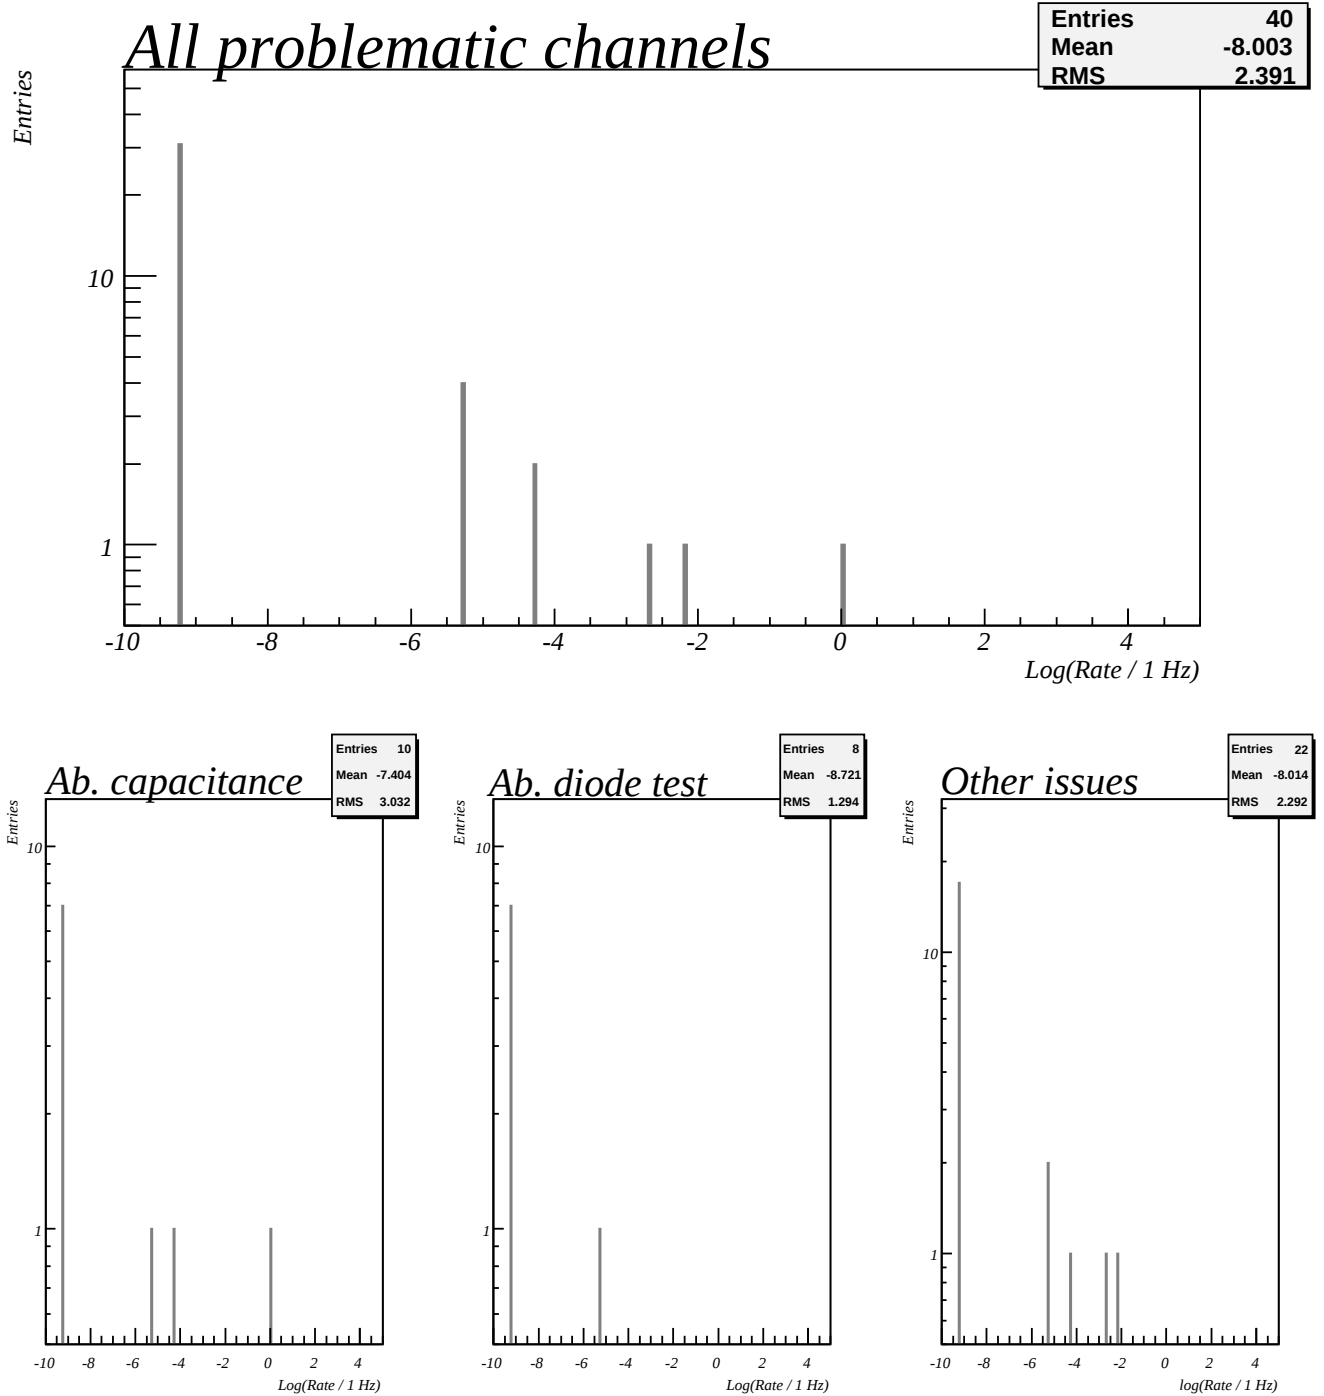
Figure 15: Dark current distribution of the different problematic channels failing the Noise Scan technique for A-type and B-type TRT wheels.
